Analytical Investigation of Damaged 320 Crankshaft

Lycoming 320 Engine

July 10, 2009

Crankshaft - P/N SL32500 - Serial Number TA07B-000430

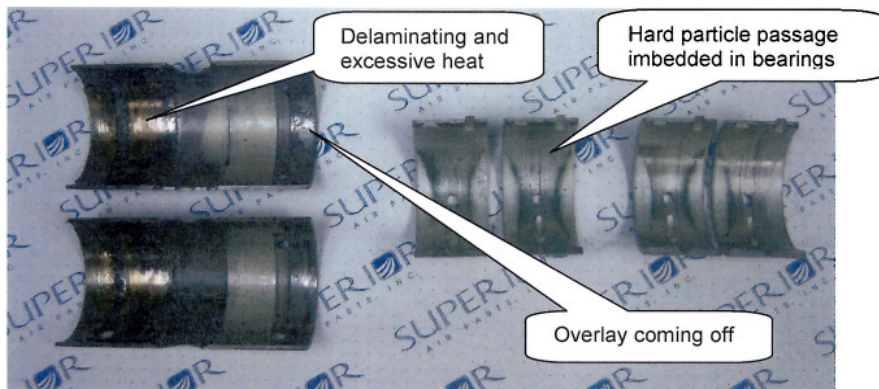
Front Main bearings show hard particle passage has been deposited in the front half of the front main bearing. No significant damage to this area at this time. Overlay on the bearing surface is just starting to come off in the first 3/8" of the bearing. Excessive bearing material is delaminating from the rear half of the front main bearing. There are excessive heat indications on the inside of the rear third of the bearing.

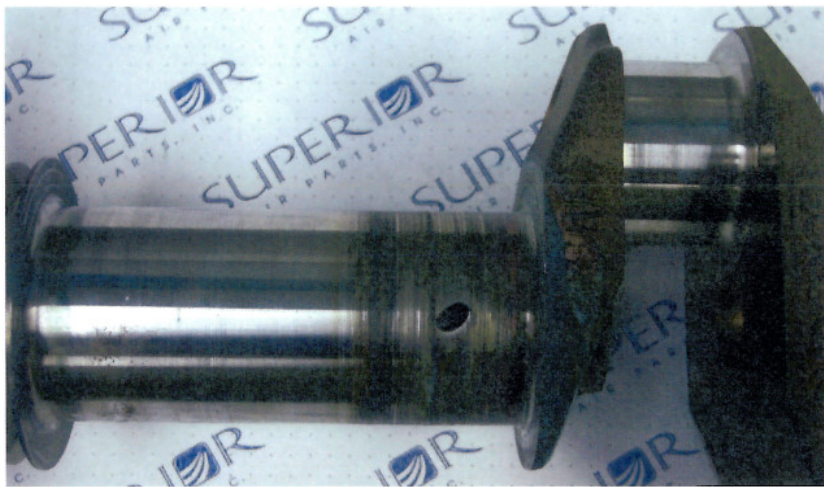
The rear third of the Crankshaft front main journal and thrust surface show indications of excessive heat and scoring.

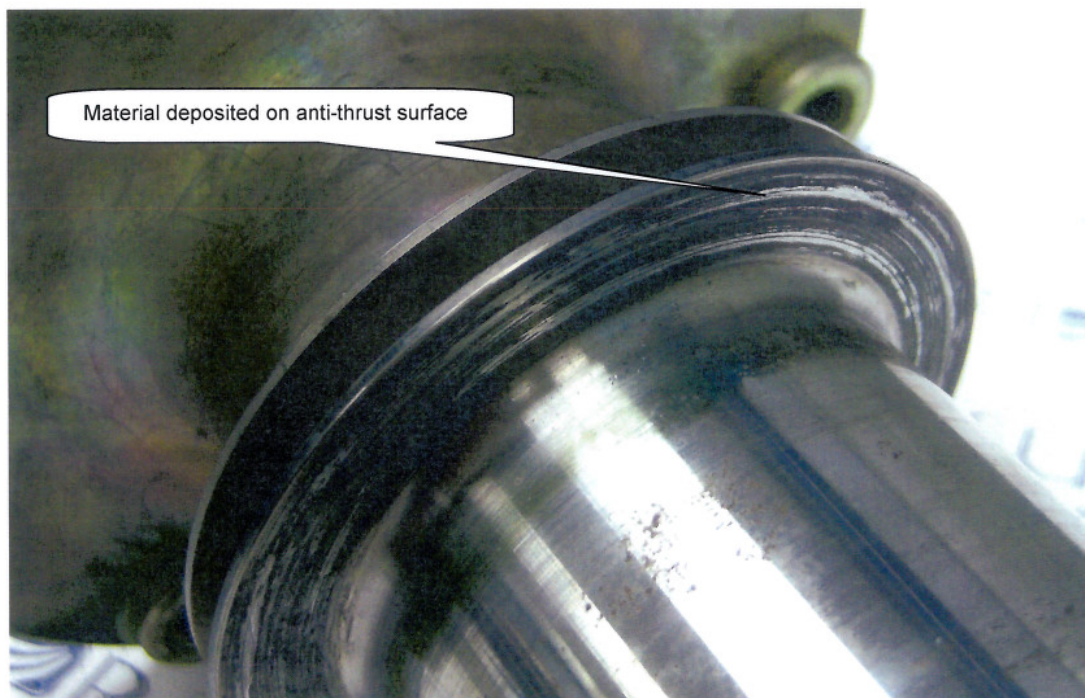
The required specification of the main journal finish prior to polishing is 10 RMS. The observed finish of the undamaged area of the main journal is approximately 8 RMS.

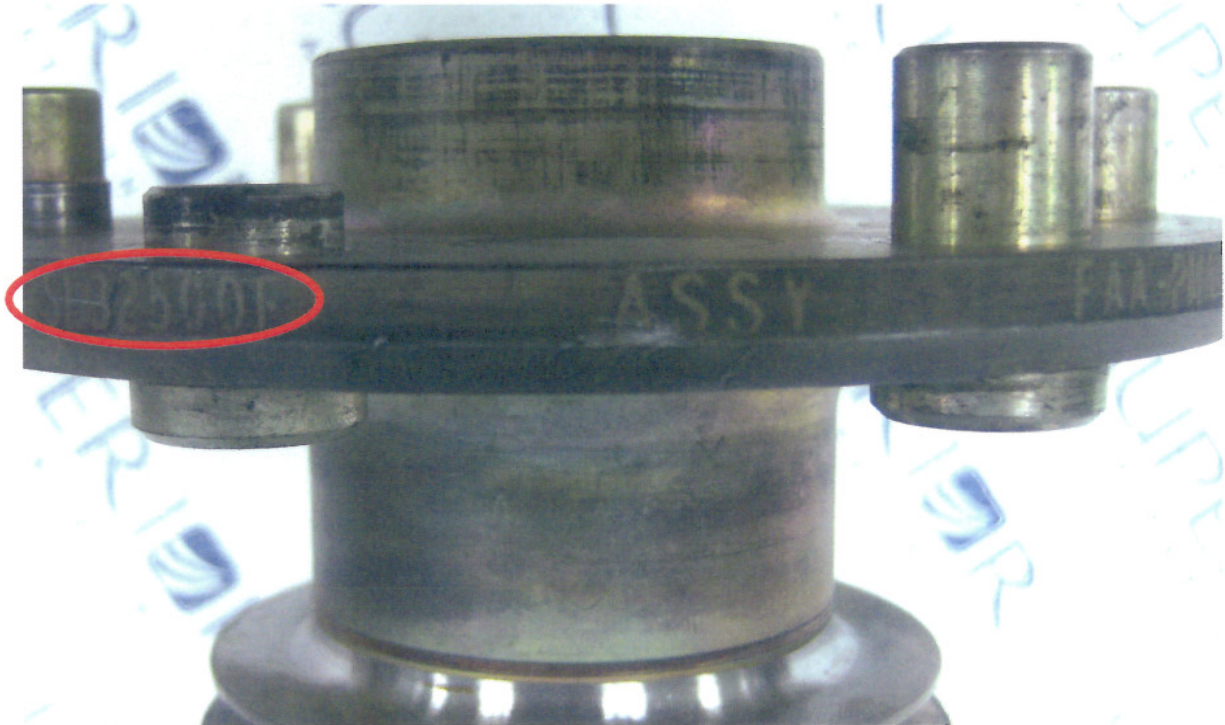
The thrust and anti-thrust surfaces have material deposited on them that appears to be aluminum from the crankcase.
